SR 1 Speed Study

Dewey Beach to MD State Line

June 8, 2021

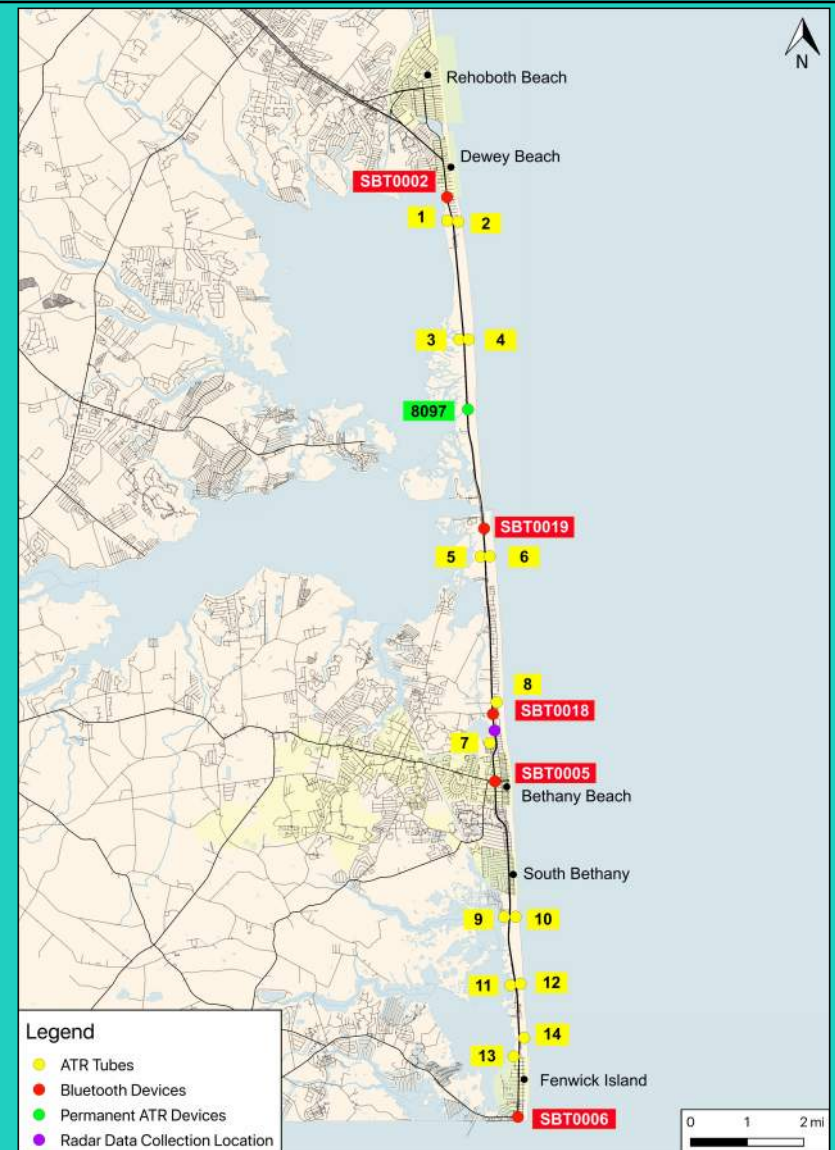
Data Collection

Device Types and Locations

ATR Tubes – 14 Locations

- Portable ATR tubes collected speed data, traffic volumes, and vehicle classification data
- Northbound and southbound data
- Data from September 2020 (1 week)

Bluetooth Devices – 5 Devices (4 Links)

- Existing, permanent devices collect travel times which are used to determine average speed between detectors
- Some Bluetooth links encompass multiple speed limit zones, and therefore are displayed as weighted averages across the link
- Northbound and southbound data
- Data from October 2019

Permanent ATR – 1 Location

- Existing, permanent device collects 85th percentile speed of vehicles in each lane of SR 1
- Northbound and southbound data
- Data from October 2019

Radar Gun – 1 Location

- Average and 85th percentile speeds collected
- Northbound and southbound data
- Data from June 2016, 11 am to 12:15 pm

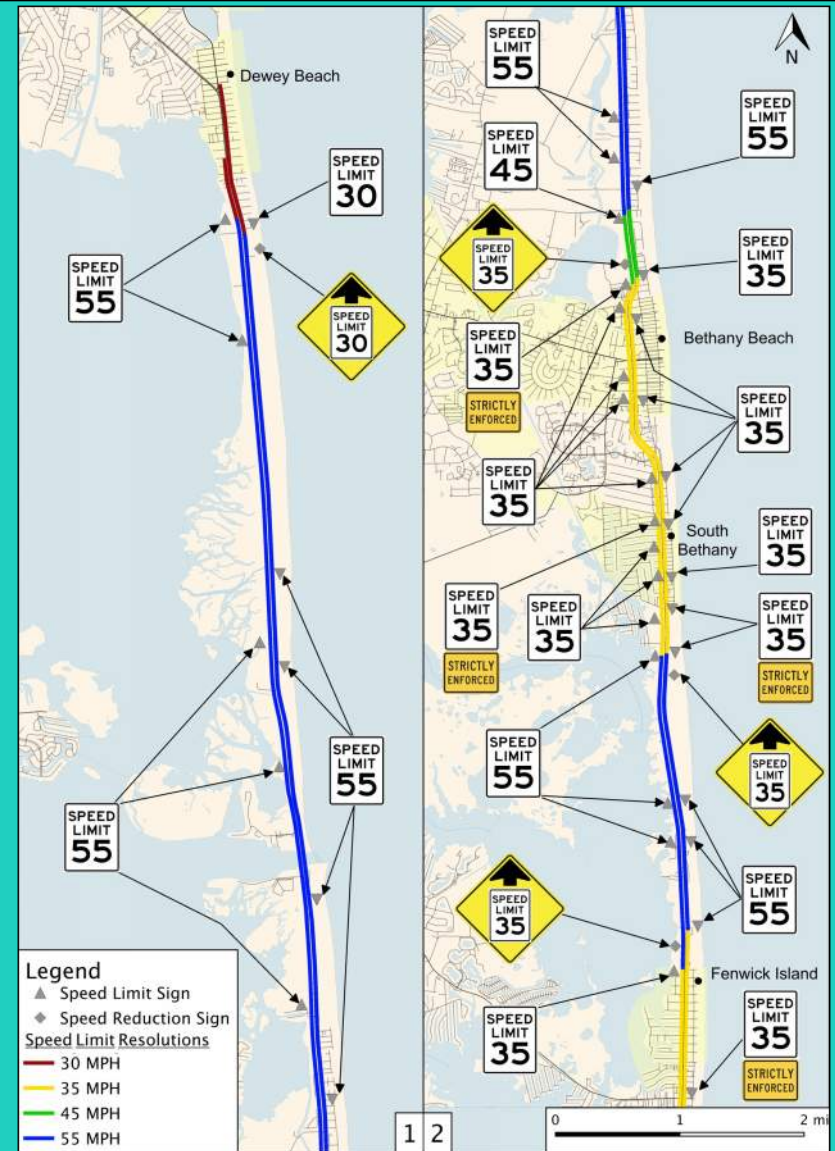
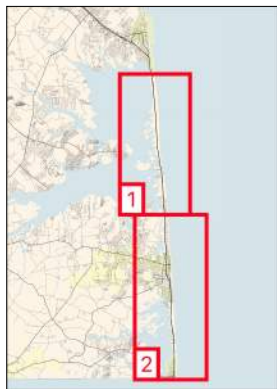
Study Area Speed Limits

Speed limits ranging from 30 MPH to 55 MPH exist within the study limits

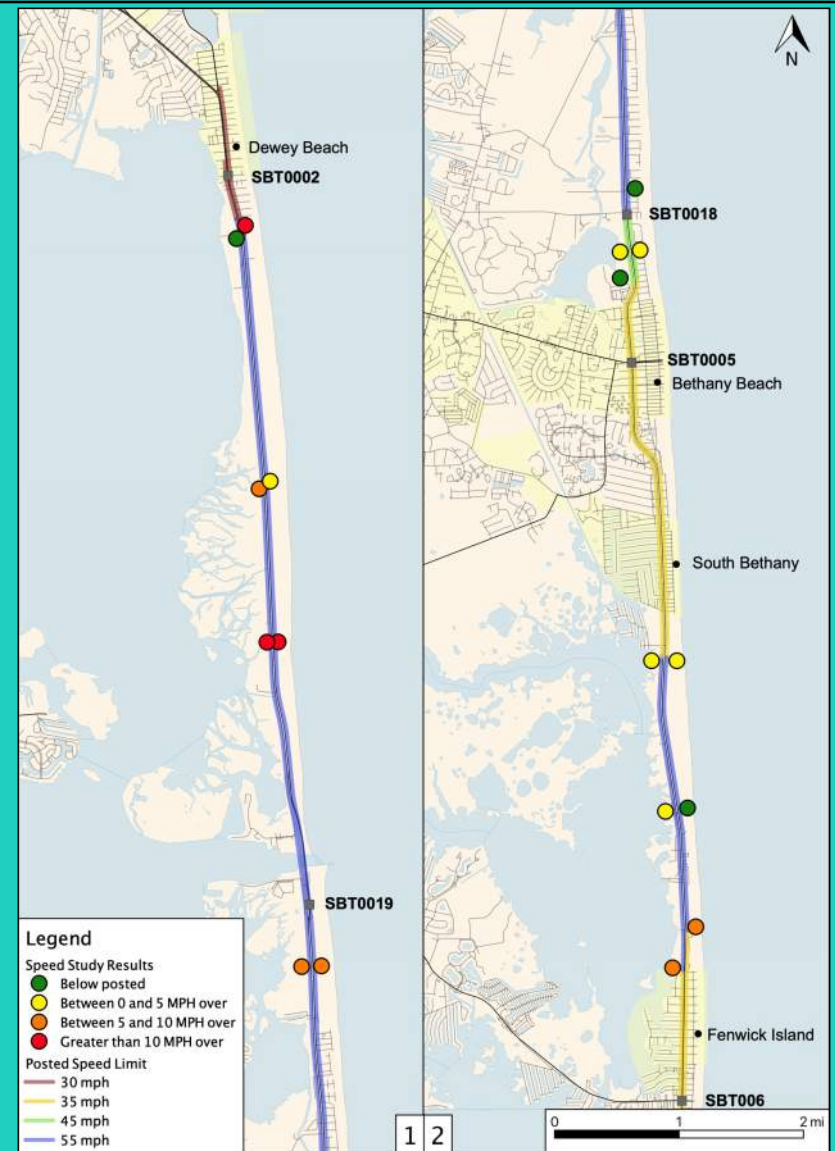
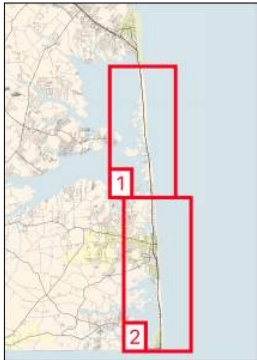
Study Area Speed Trends

85th percentile speed data in both directions was compared to posted speed limits

Notable Location Concerns:

- Vehicles are traveling greater than 10 mph over the speed limit:
 - Near Savages Ditch Rd, north of the Indian River Inlet Bridge (northbound and southbound)
 - South of Dewey Beach (northbound)
- Vehicles are traveling between 5 and 10 mph over the speed limit:
 - Between Dewey Beach and Savages Ditch Rd (southbound)
 - South of the Indian River Inlet Bridge (northbound and southbound)
 - Just north of Fenwick Island (northbound and southbound)

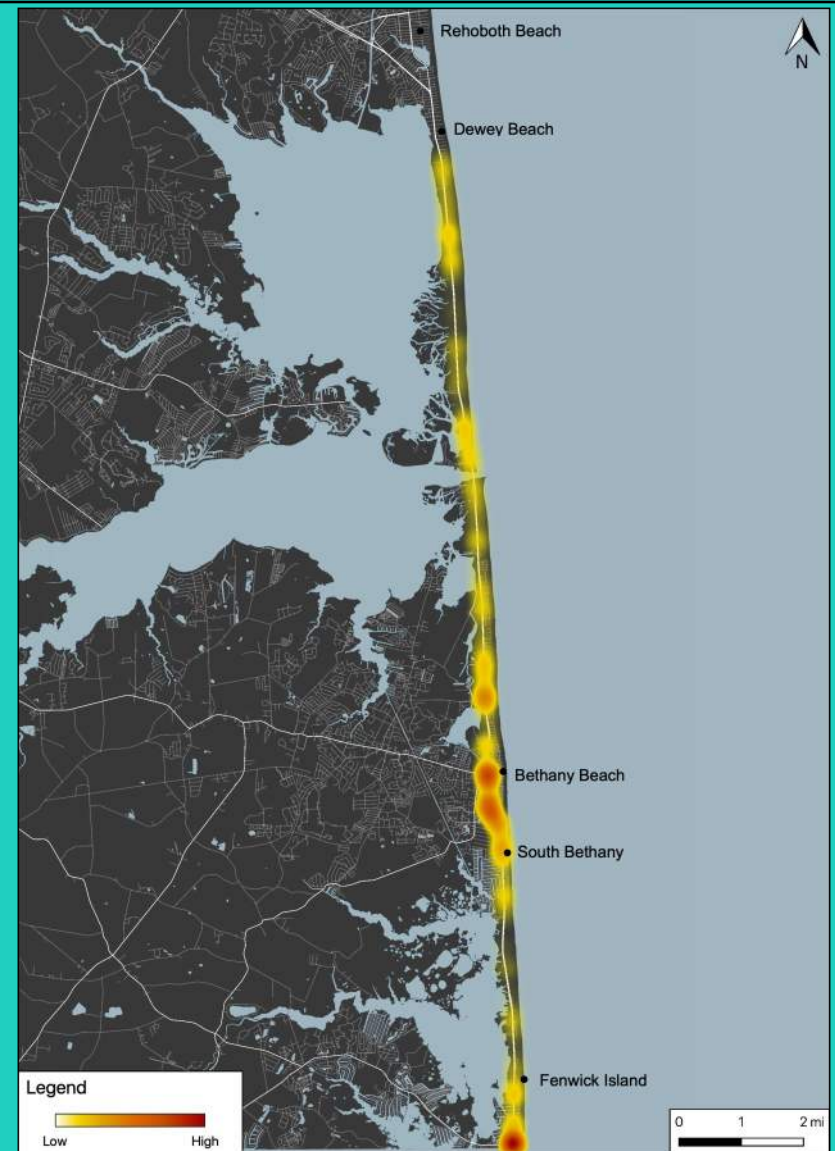
Study Area Crash Trends

5 years of crash data was collected for the study area (1/1/16 to 12/31/20):

- 435 total crashes
 - 8 fatal crashes
 - 76 personal injury crashes
 - 351 property damage only crashes
- 23 bicycle related crashes
- 9 pedestrian related crashes

Notable Crash Trends:

- Crash hot spots in Bethany Beach and Fenwick Island

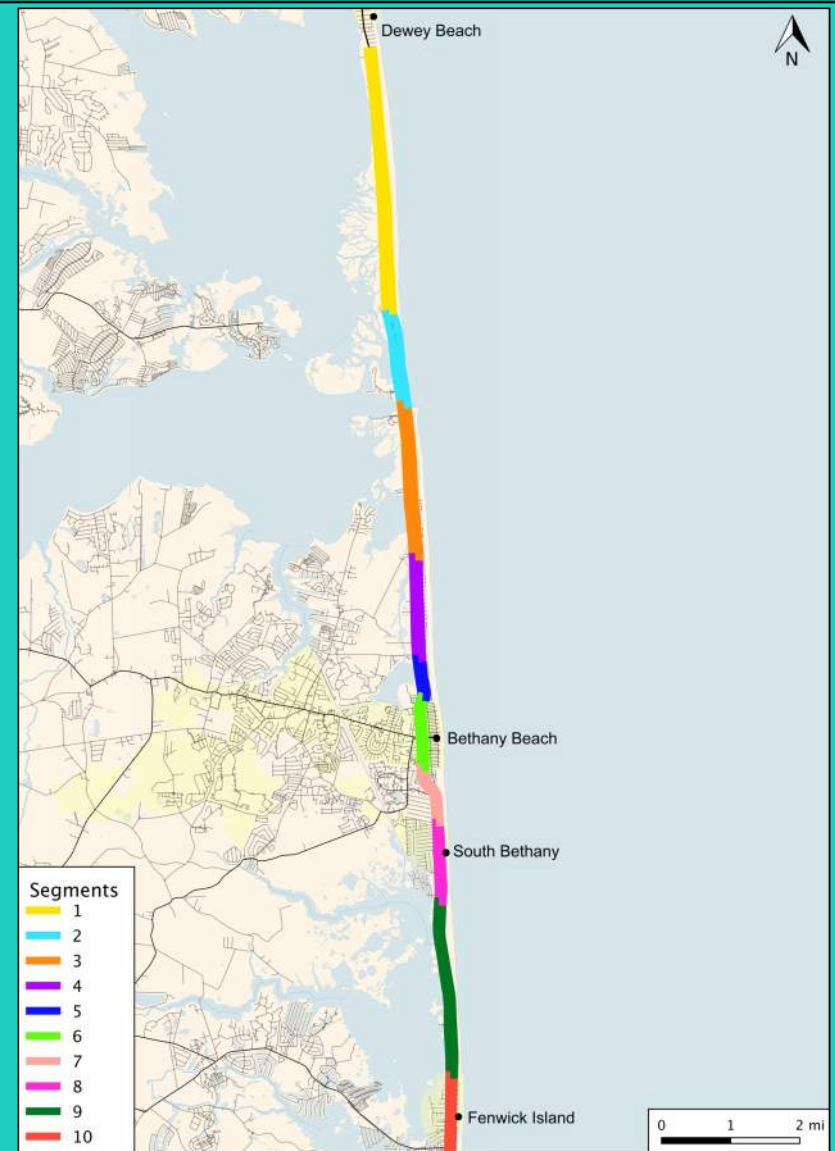
Segment Breakdown

Corridor was divided into 10 segments for detailed study, based on speed limit and roadway characteristics:

- **Segment 1:** Hall Avenue to Savages Ditch Road
- **Segment 2:** Savages Ditch Road to Indian River Inlet Bridge
- **Segment 3:** Indian River Inlet Bridge to Fresh Pond Trail
- **Segment 4:** Fresh Pond Trail to 45 MPH speed limit zone
- **Segment 5:** 45 MPH speed limit zone to 35 MPH speed limit zone
- **Segment 6:** 35 MPH speed limit zone to southern limits of Bethany Beach
- **Segment 7:** Southern limits of Bethany Beach to northern limits of South Bethany
- **Segment 8:** Northern limits of South Bethany to 55 MPH speed limit zone
- **Segment 9:** 55 MPH speed limit zone to 35 MPH speed limit zone
- **Segment 10:** 35 MPH speed limit zone to DE/MD state line

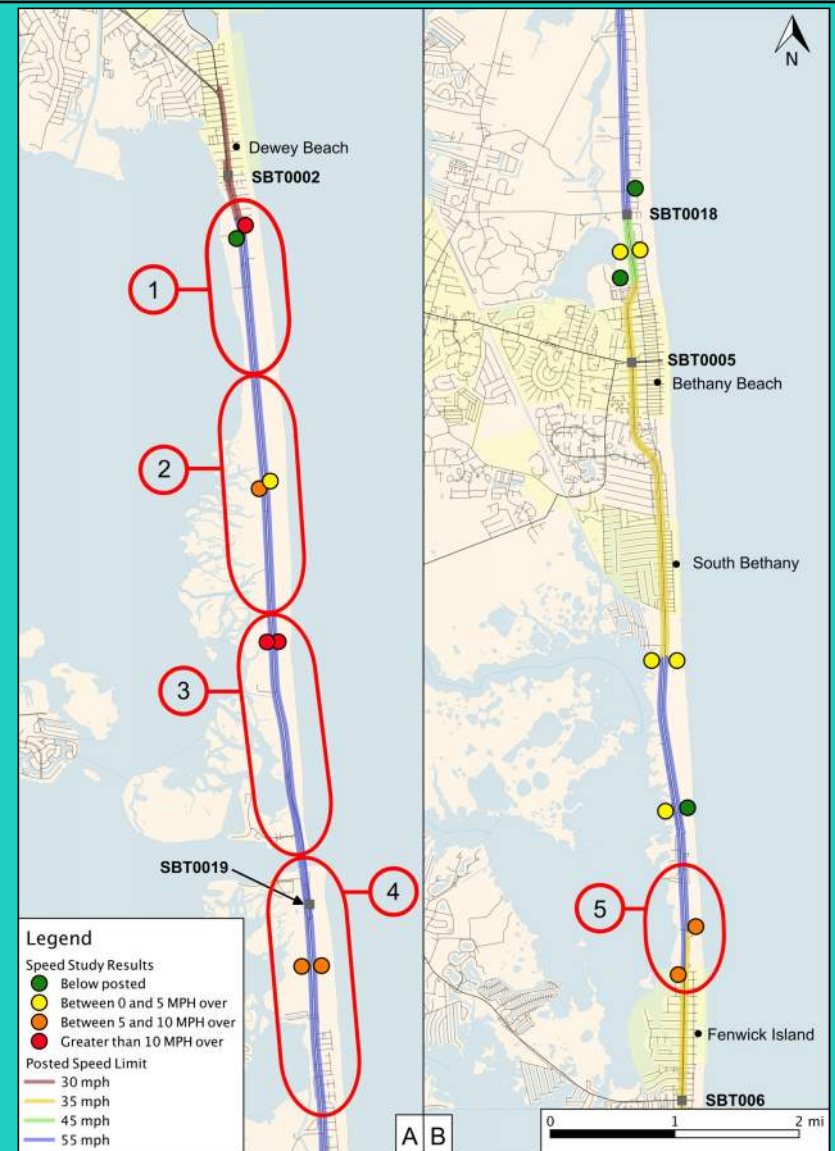
Conclusions: Speed

- Speeding concerns were noted along the corridor, especially in the following locations:
 1. South of Dewey Beach
 2. Between Dewey Beach and Savages Ditch Road
 3. Near Savages Ditch Road, north of the Indian River Inlet Bridge
 4. South of the Indian River Inlet Bridge
 5. Just north of Fenwick Island

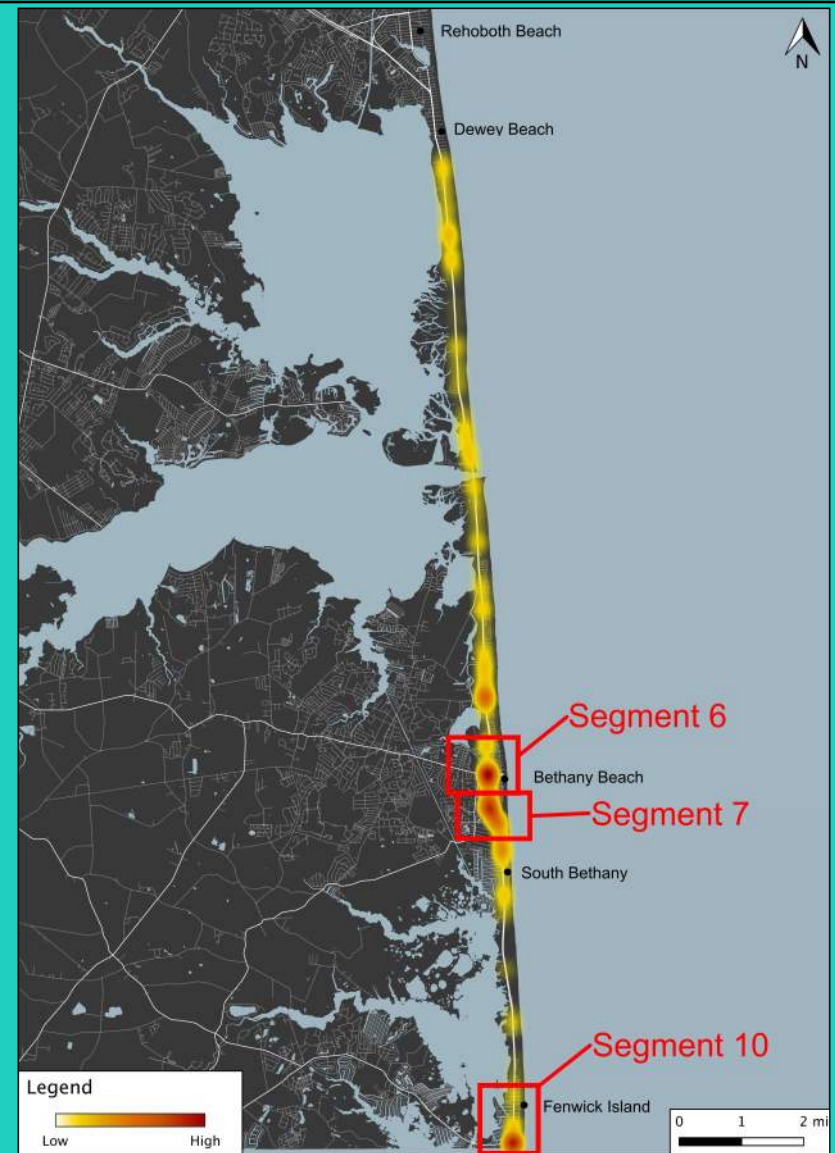
Conclusions: Crashes

- Crash rates below state average except for the following segment:
 - Segment 6 – within Bethany Beach municipal Limits
 - Segment 7 – between Bethany Beach and South Bethany
 - Segment 10 – within Fenwick Island municipal limits
- Deer collisions account for a significant number of crashes for all segments north of Bethany Beach
- Crash trends
 - Motorists not seeing bicyclists (Segment 7)
 - Pedestrians under the influence (Segment 9)
 - Rear-end/angle crashes at SR 54 intersection (Segment 10)
 - No speed-related crash trends were identified
- Crash hot spots in Bethany Beach and Fenwick Island
 - Bethany Beach (Segment 6): 68 total crashes, 3 involving bicyclists
 - South of Bethany Beach (Segment 7): 67 total crashes, 11 involving bicyclists and one involving a pedestrian
 - Fenwick Island (Segment 10): 77 total crashes, 1 involving a bicyclist and 1 involving a pedestrian

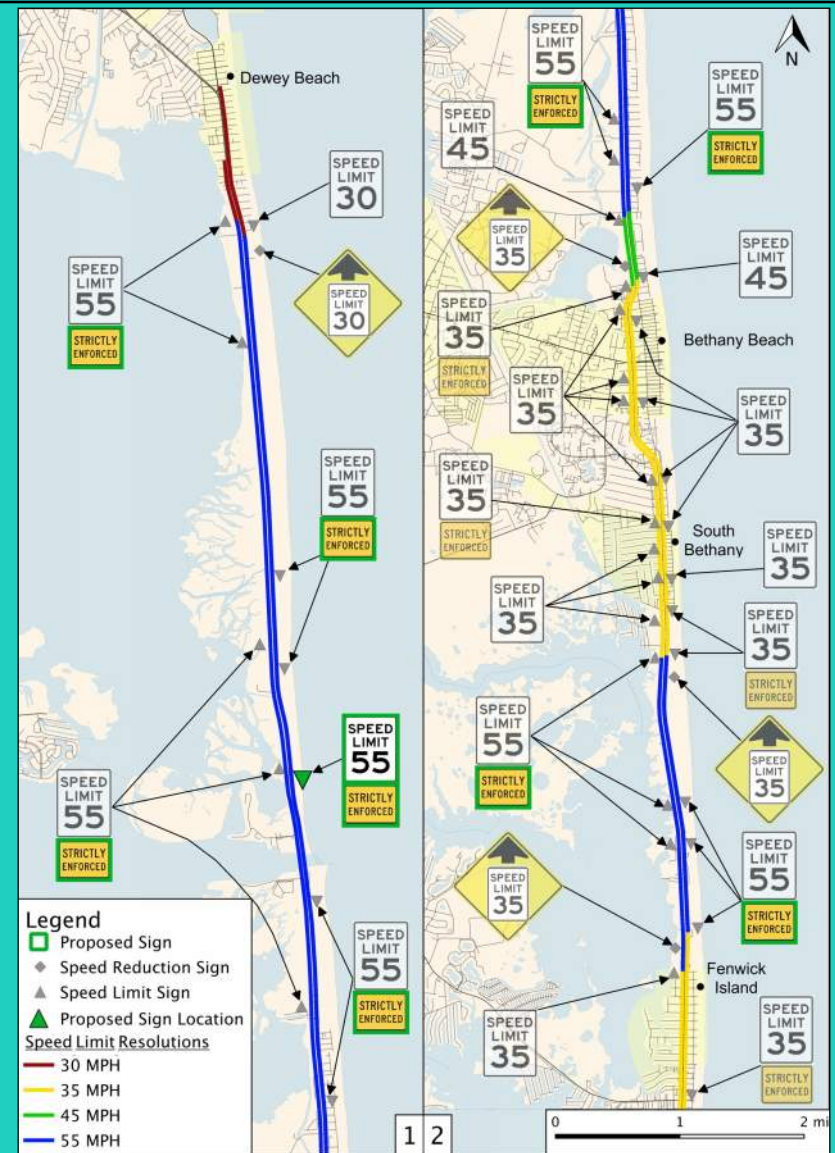
Recommendations

- Recommend speed limits remain as currently posted for all segments
- Recommend proposed signing installations including:
 - “Strictly Enforced” plaques installed below select speed limit signs, as shown
 - Additional northbound speed limit sign north of the Indian River Inlet Bridge, as shown
- Recommend targeted enforcement where “Strictly Enforced” signs are recommended
